NBSIR 75-640 (R)

Metallurgical Analysis of Wear Particles and Wearing Surfaces

Interim Report for Period October 1 through December 31, 1974
Contract 4-8049

Prepared for
Department of the Navy
Naval Air Engineering Center
Philadelphia, Pa. 19112

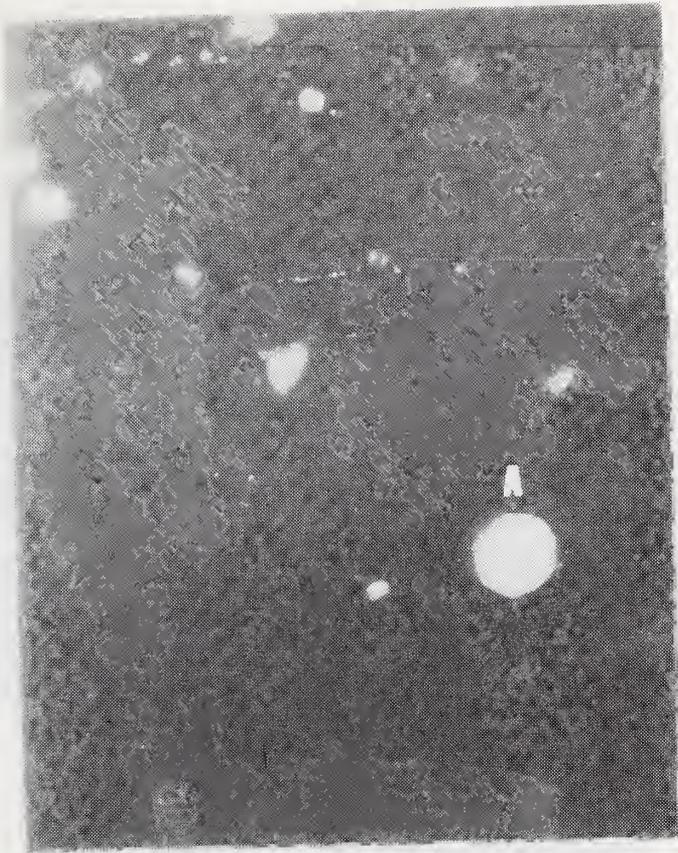
Figure 1

- Fig. 1. Optical reflected light photograph of diesel engine oil Ferrogram-3319.
- Fig. 2. Scanning electron micrograph of entry region in F-3319.
- Fig. 3. Details in F-3319, compare with Fig. 1.

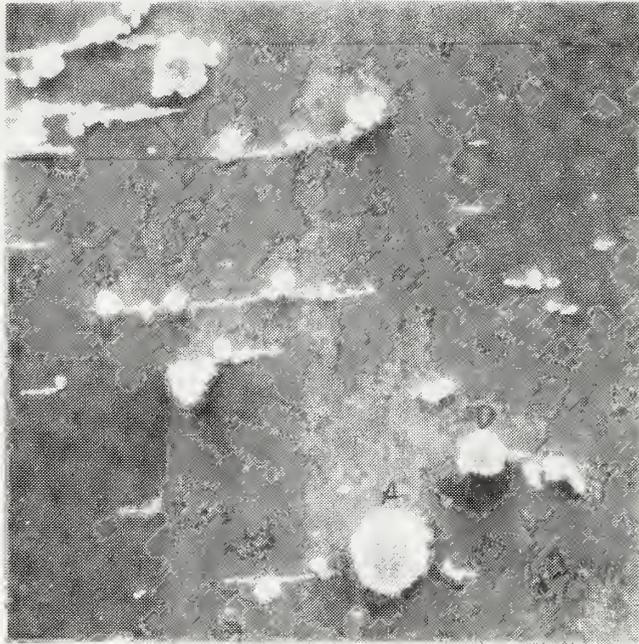
Particle A: 3S + 1Cr
C: Fe + trace S
D: 1S + 3Ca
F: 1S + 2Ca + 3Fe
G: 1S + 1Ca
H: 1S + 1K + 3Ca

An unusual wear debris specimen was examined in detail following preparation and study by Trans-Sonics. The specimen was obtained from a diesel engine and was found to contain relatively large, bright yellow particles in addition to the usual iron wear particles. Other mineral-appearing particles were also noticed in the Ferrograms that were prepared. Figure 1 shows an area from one Ferrogram containing several large yellow colored particles as viewed in white, reflected light. The Ferrogram was coated with a thin layer of deposited carbon in a vacuum evaporator as previously described and then examined in the scanning electron microscope. Figure 2 shows the entry deposit region (oil flow is downward). Figure 3 provides detail in the region indicated in Fig. 2. Particle A is the original particle of interest. X-ray microanalysis was conducted on particle A and several other particles on the Ferrogram. The spectrum from particle A is shown in Fig. 4 to consist of principally sulfur and chromium. The small silicon contribution probably originates from the glass slide substrate. Particle C (actually several small particles) is the usual iron wear fragment found in particle strings on the Ferrogram as confirmed by the spectrum shown in Fig. 5. Relative analyses of all particles labeled in Fig. 3 are as follows:

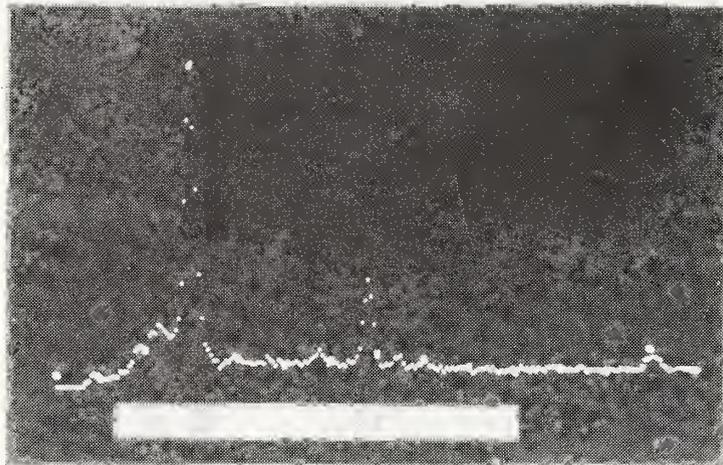
Figure 4

- Fig. 4. X-ray spectrum from particle A in Fig. 3.
- Fig. 5. X-ray spectrum from particles C in Fig. 3.
- Fig. 6. Details in another area of Fig. 2.
- Fig. 7. Optical reflected light photograph of F-3356 after heating to 330°C.

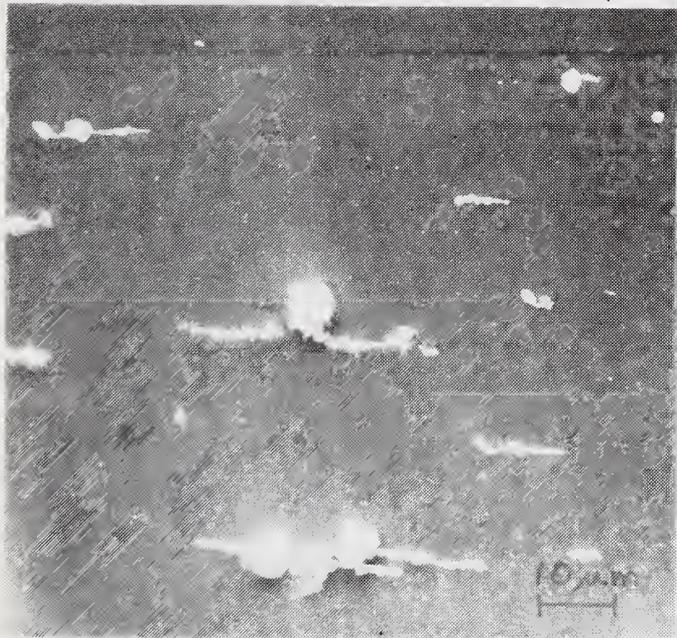
Pb = 9.7, Sn = 5.0, Al = 23, Zn = 42, Ca = 248. An unusually high Ca content was found in several of the individual particles analyzed. Figure 6 shows another area near the initial deposit point, also marked in Fig. 2. The larger particles in this area also were found to contain a significant amount of sulfur. In view of the location of these sulfur-containing particles, at the end of or imbedded within magnetic particle strings, it is clear that these sulfur-containing particles contain a significant amount of iron or smaller iron wear particles. It is not clear whether actual sulfur-iron compounds are involved here or whether a physical aggregation process occurs. In view of the possible increased use of higher sulfur-containing fuels and lubricants in our technology, the influence of sulfur in wear debris analysis (if any) needs examination.

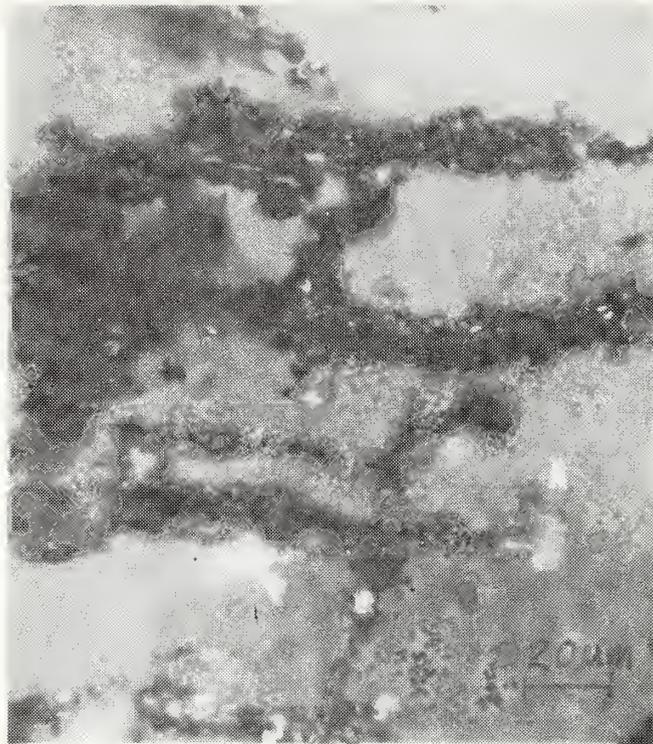
This specimen was provided through Trans-Sonics after an inquiry into what information might be deduced from a wear debris particle examination. The actual mechanical system involved was not revealed. The results are presented here as unusual and illustrative. Figure 7 is a reflected, white light photomicrograph of one region of the Ferrogram after heating to 330°C. That treatment caused a blue coloration of the iron and steel debris and is one principal analytical step taken in the examination of many Ferrograms from mixed-metal systems. Note that the particle labeled A (and several others) have a distinctively different color.

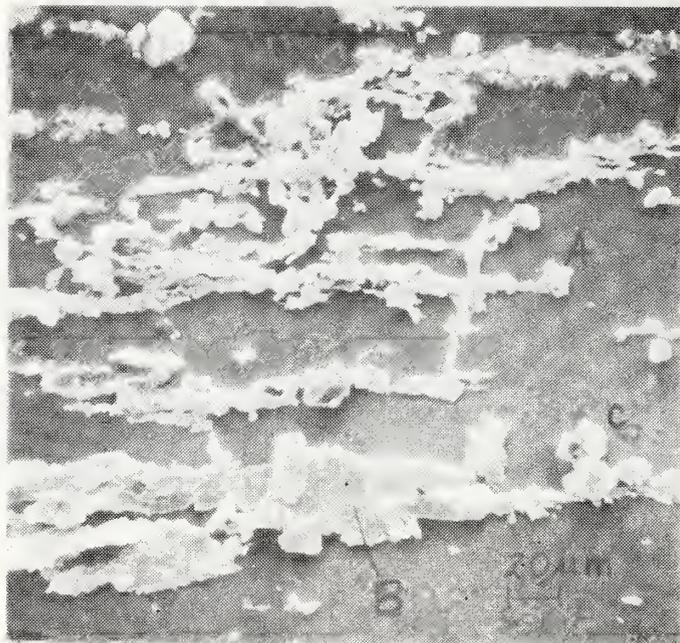
The Ferrogram was carbon-coated by vacuum deposition and examined in the SEM. Figure 8 shows the area near the entry deposit containing particle A. Several unusually large flake particles are seen, as are numerous larger, equi-axed particles, all generally oriented with the iron wear particle strings. X-ray microanalysis indicated that particle A was composed of chromium, probably originating in a Cr-plated portion of the mechanical system. Figure 9 shows the emission spectrum for A. Particle B gave a very similar, Cr-rich spectrum. Particle C and others of similar appearance were rich in calcium and gave evidence of containing significant oil residue. The region of the particle

- Fig. 8. Scanning electron micrograph of region in Fig. 7.
- Fig. 9. X-ray spectrum from particle A in Fig. 8.
- Fig. 10. Particle string containing two iron spheroids adjacent to area of Fig. 8.

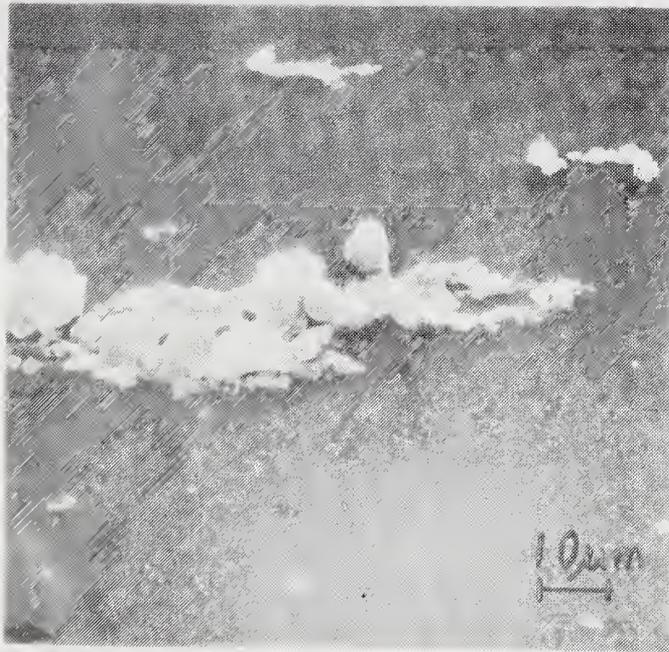
Figure 10

string to the right of particle C in Fig. 8 is shown in Fig. 10. Several small flake particles are seen here along with two 4 μm diameter spheroids. Analysis of the spheroids indicated only an iron content. Many other spheroids were observed in this Ferrogram. Further down from the initial deposit, a nonmagnetic copper particle was found and is shown as D in Fig. 11. Note that the smaller iron particles still deposit in a laterally oriented string-like configuration, quite distinct from the larger particles nearby. That difference suggests the nonferromagnetic composition as verified in the case of particle D.

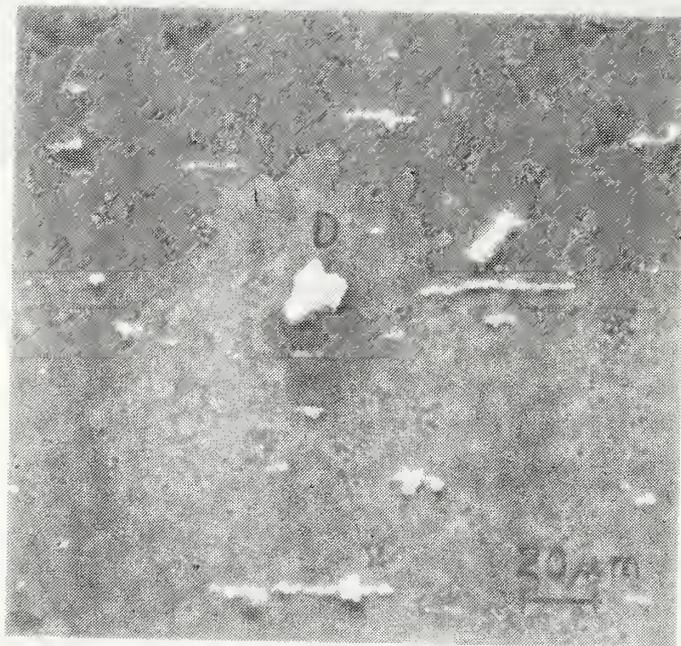
Figure 11

- Fig. 11. Region of F-3356 downstream from entry deposit. Particle D is principally copper.
- Fig. 12. Ferrogram-3420 deposit; optical micrograph of 5 μm Ni/SiO₂ spheres.

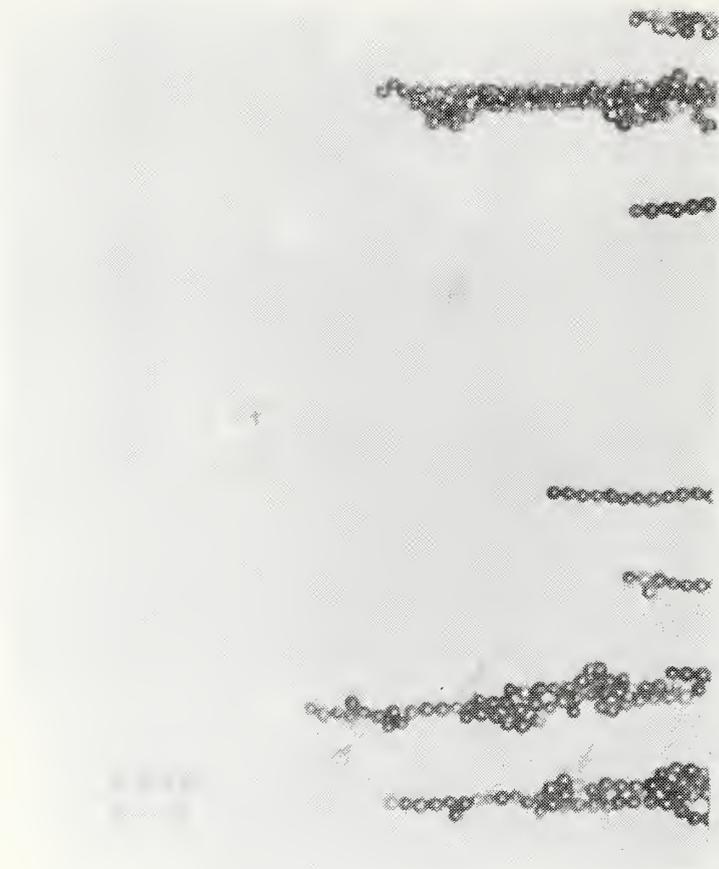
Figure 13

- Fig. 13. Optical photograph of strings near entry deposit. Note transparent spheres marked.
- Fig. 14. Entry deposit of F-2897, scanning electron micrograph, collection of 5 μm Ni/SiO₂ spheres.

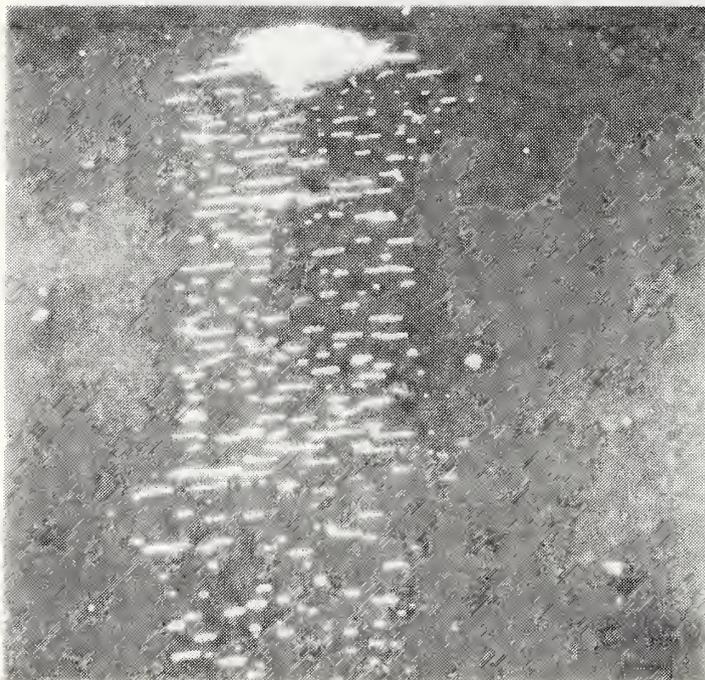
Another experiment has been conducted using only nickel-coated 5 μm spheres. The mechanism of lateral growth of the particle strings as additional particles pass over them was of interest. Figure 14 shows a scanning electron micrograph of the entry deposit region of that Ferrogram (F-2897). Note again the gradual decrease in particle density along the flow direction. Figure 15 indicates some detail adjacent to the entry deposit. The usual process of deposit thickening appears to involve the addition of a second row of particles on the substrate adjacent to the first row. Another particle row can then deposit on top of the two lower rows, etc. Lateral lengthening and thickening appear to go on together. The unusual background contrast near the strings in this example is due to residual oil left on the Ferrogram. The carbon film deposit does not adhere in the regions of this oil and particle charging in the electron beam can occur. This problem is most serious in any Ferrogram examination since the debris particles are not fixed to the substrate in such cases and can be dislodged and lost. Figure 16 illustrates this effect in this sample. Locations of several short strings of particles are shown to be empty (A) and displaced, single spheres are seen at random adjacent locations.

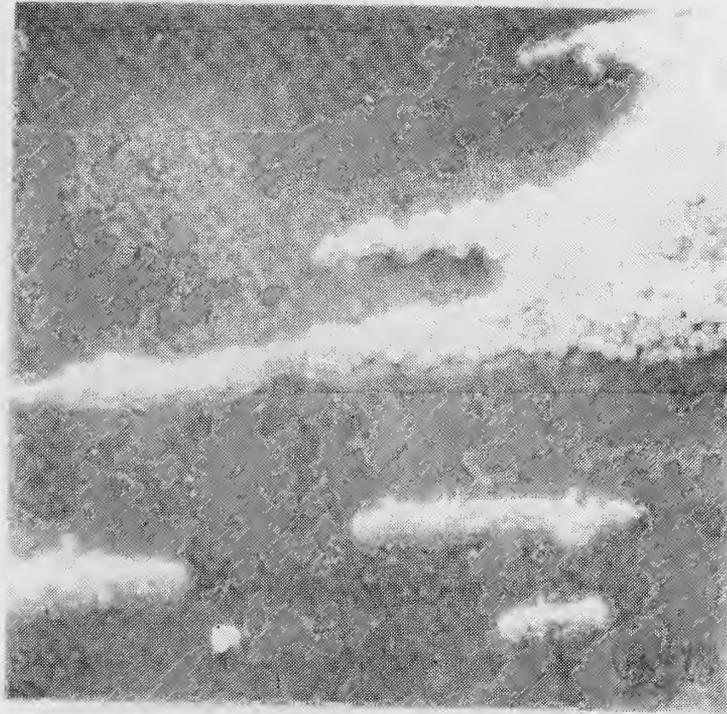
Figure 15

- Fig. 15. Details of particle strings near entry deposit.
- Fig. 16. Instability of particle strings due to oil contamination.
- Fig. 17. Scanning electron micrograph near entry deposit of F-2902, containing 5 μm and 0.7 μm Ni/SiO₂ spheres.

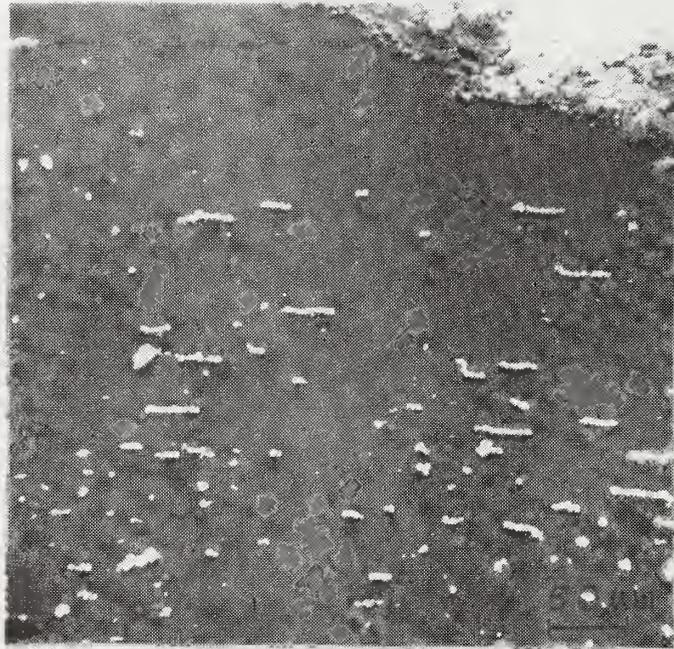
Figure 17

A mixed sample of nickel-coated spheres of 5 μm and 0.7 μm diameter is also being studied. The emphasis here concerns the growth and characteristics of the particle strings when a bimodal size distribution of particles is present. An area near the entry deposit in F-2902 is seen in Fig. 17. The particle strings here are all rather short and unconnected due to a lower particle density and coverage. Figure 18 shows some details near two strings. The small spheres appear in clusters in and on the end of many strings; they also appear in isolated locations, usually clustered in groups of five or more. It is not expected that the 0.7 μm spheres should deposit consistently in the same strings with the 5 μm spheres unless they are clustered into larger effective sized units in the oil. Further experiments will examine the tendency to cluster and methods for better dispersion.

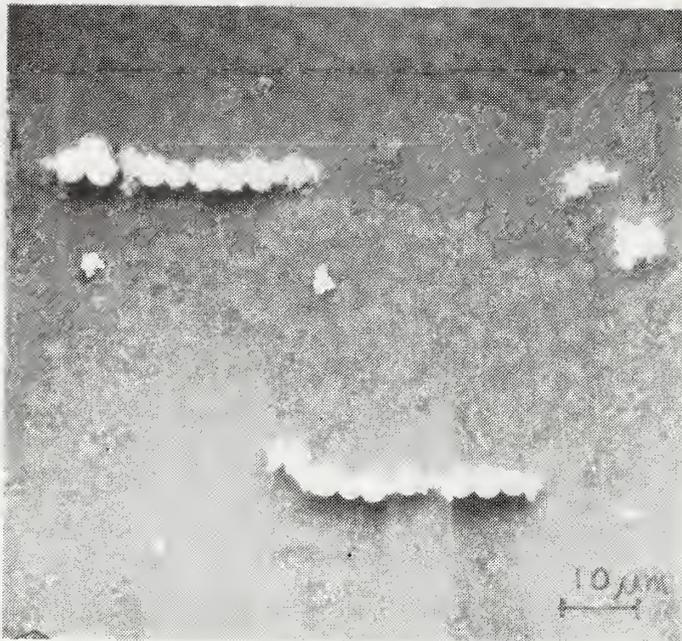
Figure 18

- Fig. 18. Details of particle strings in F-2902.
- Fig. 19. String of both sized spheres in F-2902. X-ray data obtained from marked spheres (see text).

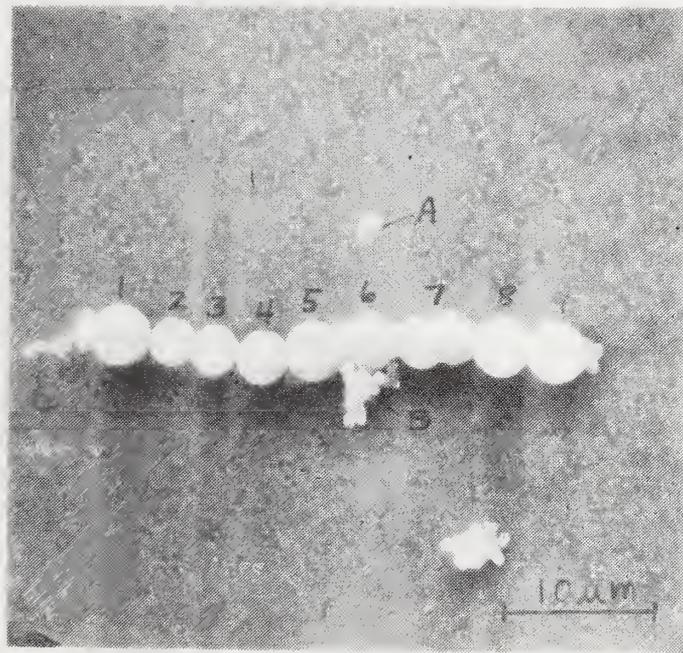
Figure 19

Another string of mixed size spheres is shown in detail in Fig. 19. Some small clusters of 0.7 μm spheres are seen at the ends and along this string. Clearly small submicron wear debris would behave in a similar manner relative to large particles.

Further studies are in progress on the reliability of X-ray microanalysis methods applied to particle collections in the micron size range. The particles labeled in Fig. 19 were examined under constant electron beam exposure and geometrical conditions. The Ni-K α X-ray line emission was measured in each case using the SEM X-ray detector system. The results are given below.

Particle	1	2	3	4	5	6	7	8	9	A	B	C	1R	9R
Time for 10 ³ counts (sec.)	108	87	79	70	77	104	76	60	58	350	112	360	99	53

Particles A, B, C are actually clusters of the smaller spheres. The variation in Ni count rate for the 5 μm spheres is due partially to statistical variations (about 6%) and partially to a real variation in Ni content of the spheres. The observed average value is 80 ± 18 sec., a variation of about 25%. The string was rotated 180 degrees in the SEM and the end particles reanalyzed. The values (1R, 9R) are not significantly different than the original values, indicating that electron excitation from adjacent particles is not a significant factor. The Ni emission from the cluster of small spheres B is reasonably close to that from the larger spheres suggesting a similar Ni content. The clusters A and C appear thinner and penetration of the electron beam would be more significant.

of about 0.3 is indicated for correction at 0.7 μm diameter. Considering particle clusters A and C in Fig. 19, the corrected time for 10^3 counts would be $(350)(0.3) \approx 100$ sec., which is reasonably consistent with the values for the 5 μm spheres.

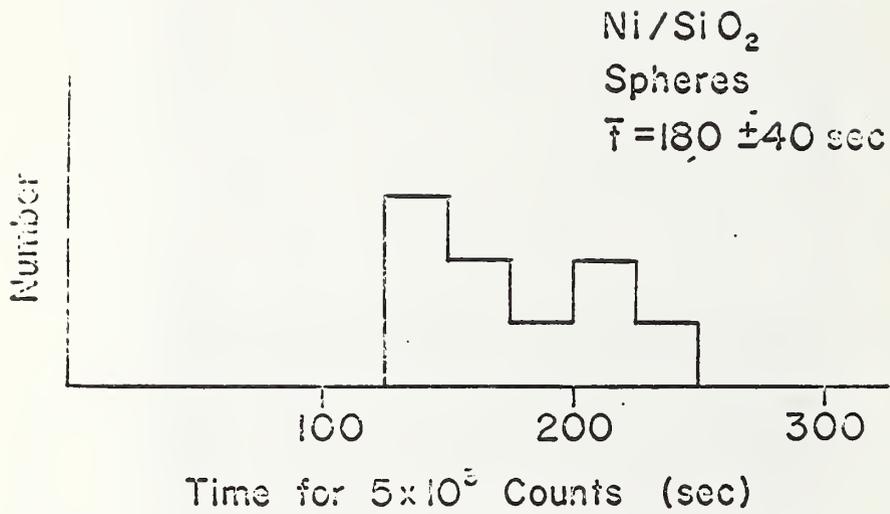
Figure 20

- Fig. 20. Number of 5 μm Ni/SiO₂ spheres giving rise to fixed Ni-K _{α} counts vs. count time. Indicates uniformity of nickel content in selected, isolated spheres.

A previous study of the Ni-coated 5 μm spheres, selected to be isolated from other spheres on the substrate, revealed the variation in Ni content shown in Fig. 20, also about 25%. Calculations and experiments on the effect of penetration of small particles by the electron beam and subsequent X-ray emission have been reported last quarter. Figure 21 shows the results for iron (nickel results are nearly identical). No correction for X-ray emission is needed for the 5 μm spheres. However, a factor

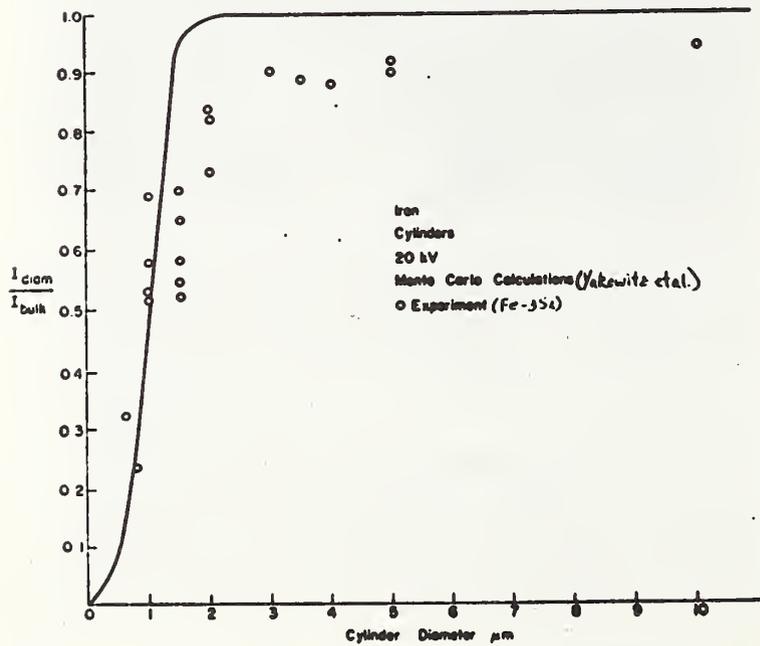
Figure 21

- Fig. 21. Experimental data and calculated curve showing effect of particle size on X-ray emission intensity for iron (nickel nearly identical).
